# Optimizing Warehouse Safety & Efficiency

A COMPREHENSIVE CASE STUDY ANALYSIS OF BILATERAL  
COLLISION AVOIDANCE SYSTEM (HALOGUARD360) WITH  
LOCATION POSITIONING IN WAREHOUSE OPERATIONS

3/11/24

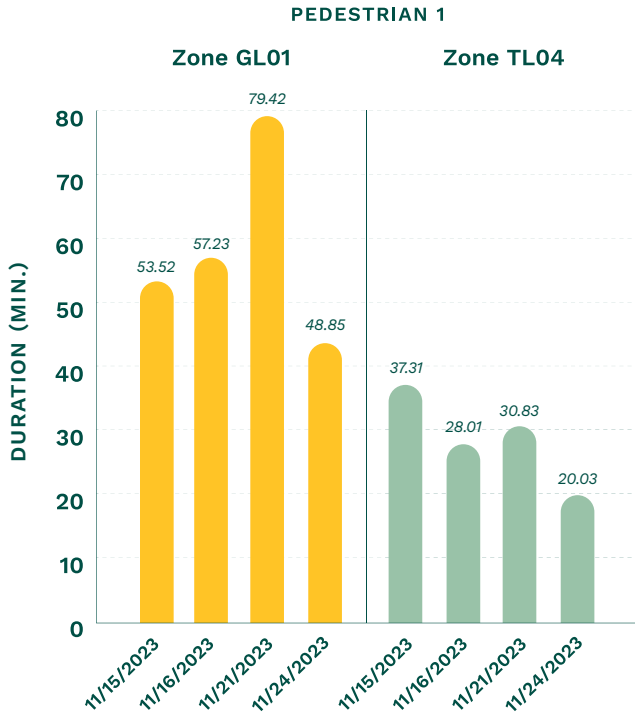
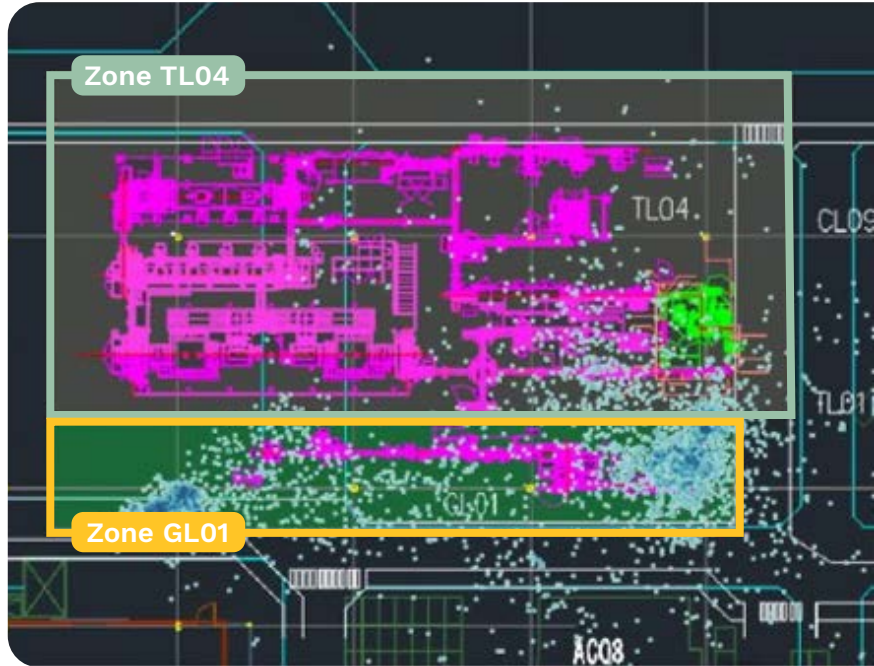
### Pedestrian Time Spent in Each Zone

- a. Deployment of our UWB location beacons in the necessary areas for coverage.
- b. Defined multiple zones within the warehouse, with each production line being treated as a single zone.
- c. Utilized Location Positioning system to track pedestrian movements within the warehouse, focusing on specific lines on the warehouse map. This allowed us to accurately determine the amount of time spent by pedestrians in each zone.

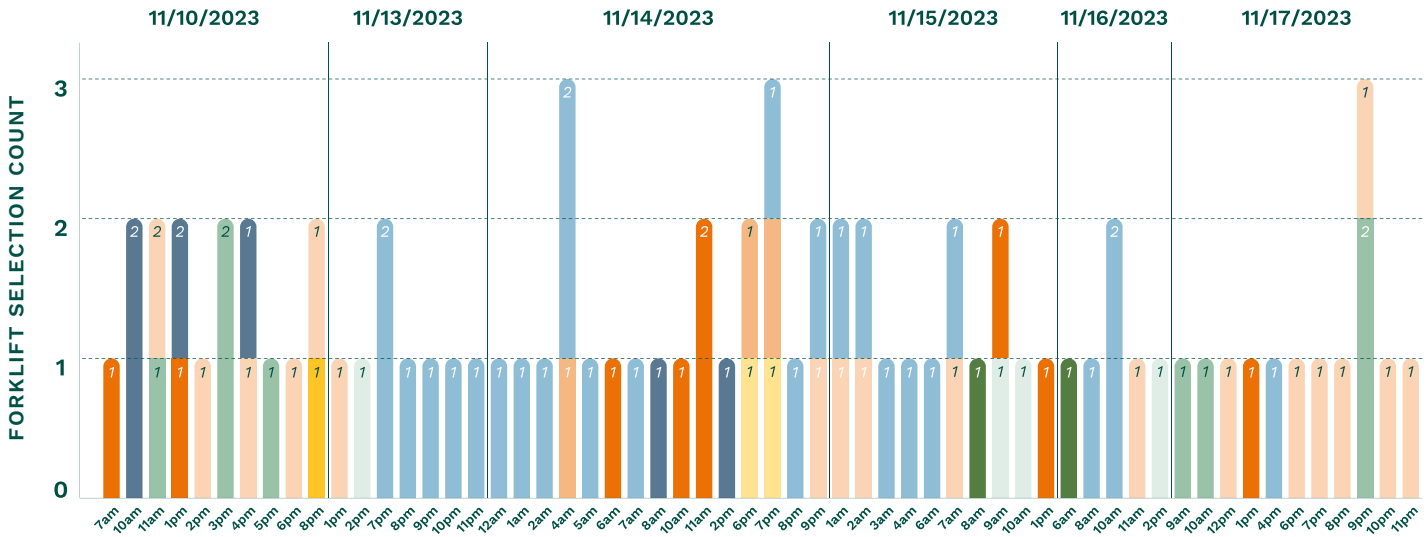
### Forklift Utilization by Day and Hour

- It was observed that the maximum number of forklifts in use simultaneously was 3 out of 9 forklifts.

- Forklift #1
- Forklift #3
- Forklift #5
- Forklift #7
- Forklift #9
- Forklift #2
- Forklift #4
- Forklift #6
- Forklift #8

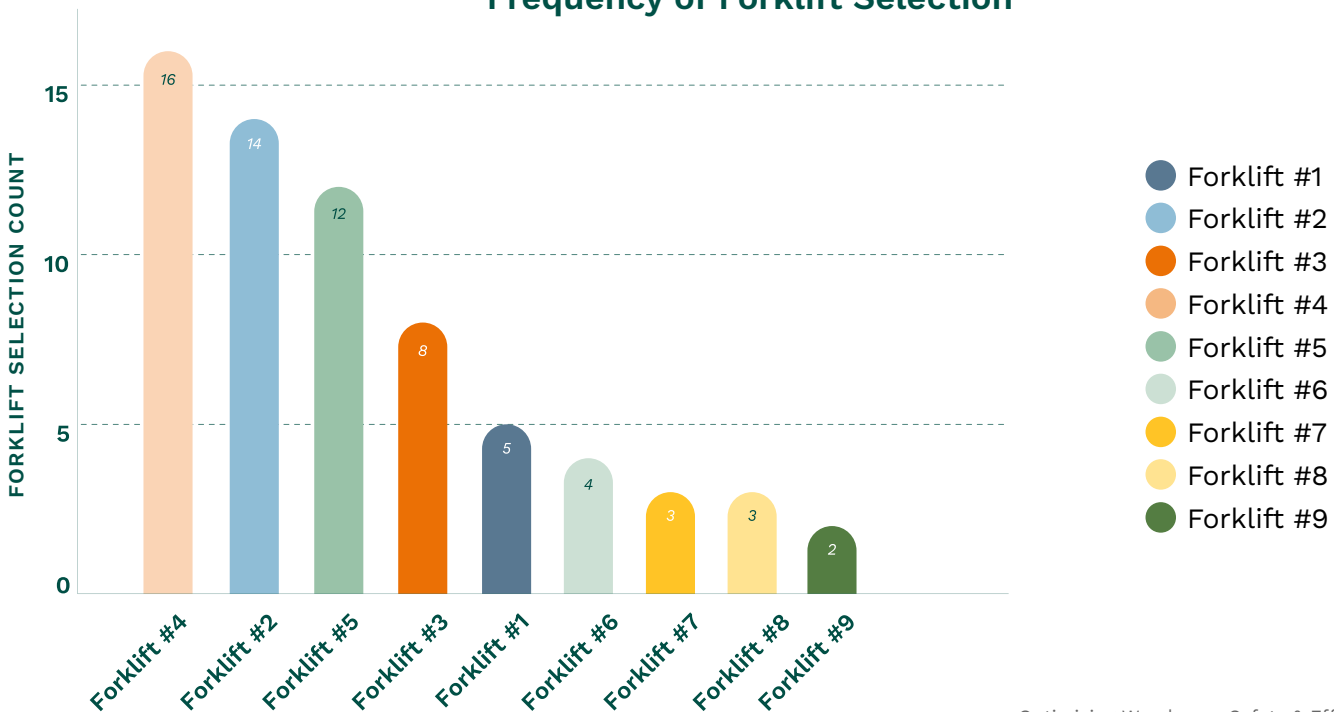
### Frequency of Forklift Selection

- Drivers showed a preference for Forklift 4 over Forklift 9, with Forklift 9 being utilized the least.

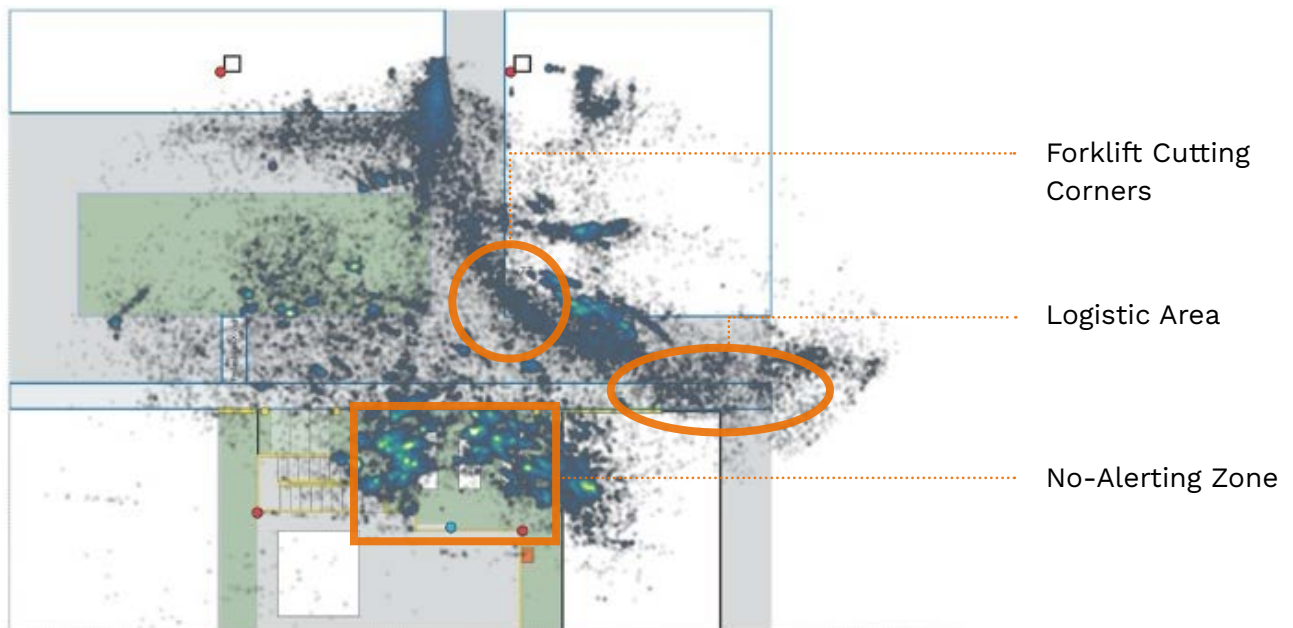
Traffic Map

- Hotspots were identified in aisles with low visibility where many were occurring.
- Utilizing the Location Positioning System, it determined that the logistics area experiences high traffic due to frequent loading and unloading activities. Additionally, it was discovered that drivers tend to cut corners during their turns.
